# Manhole Inspection Summary

Manhole # S29KK\_021MH

**Location** Address: **600 NORTH AVE**

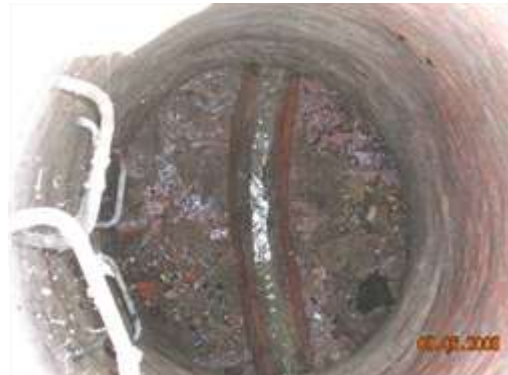
Top View

Corroded steps. Evidence of surcharge - Bench debris.

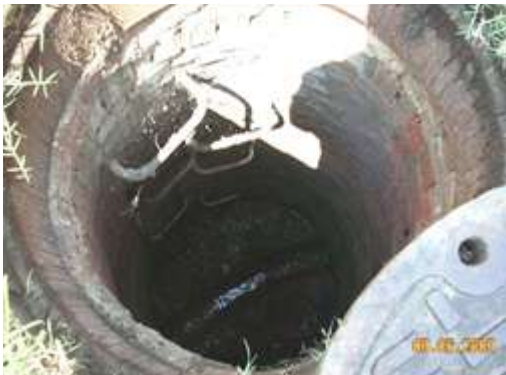
Defect

Adjustment deterioration and infiltration. Corbel and Barrel infiltration - other side.

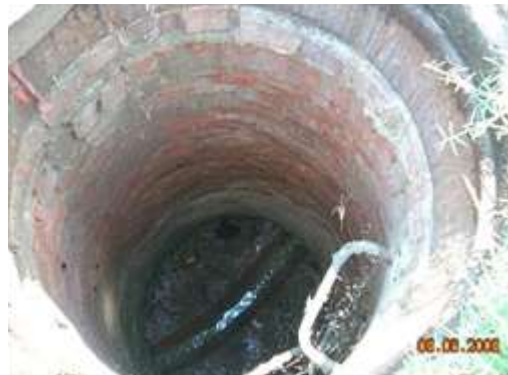
Defect

Adjustment deterioration and infiltration. Corbel and Barrel infiltration.

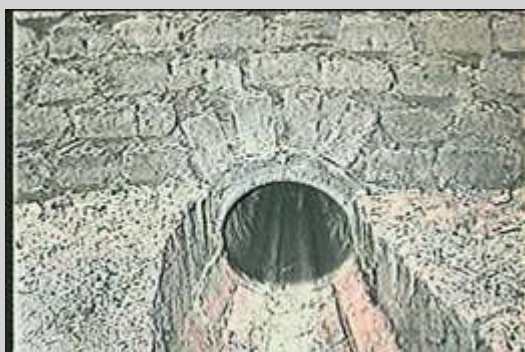
Pipe Out @ 12 O'Clock

Infiltration: **Evidence** Pipe Seal Cond: **Unknown**

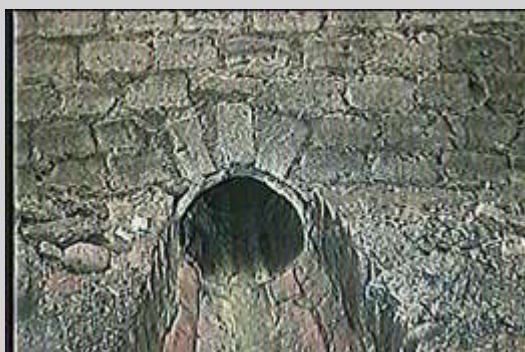
Pipe In @ 5 O'Clock

Barrel deterioration and infiltration. Channel deterioration.
